# Ground Investigations Ireland

## Whitestown Way Tallaght

## Ground Investigation Report

### April 2026

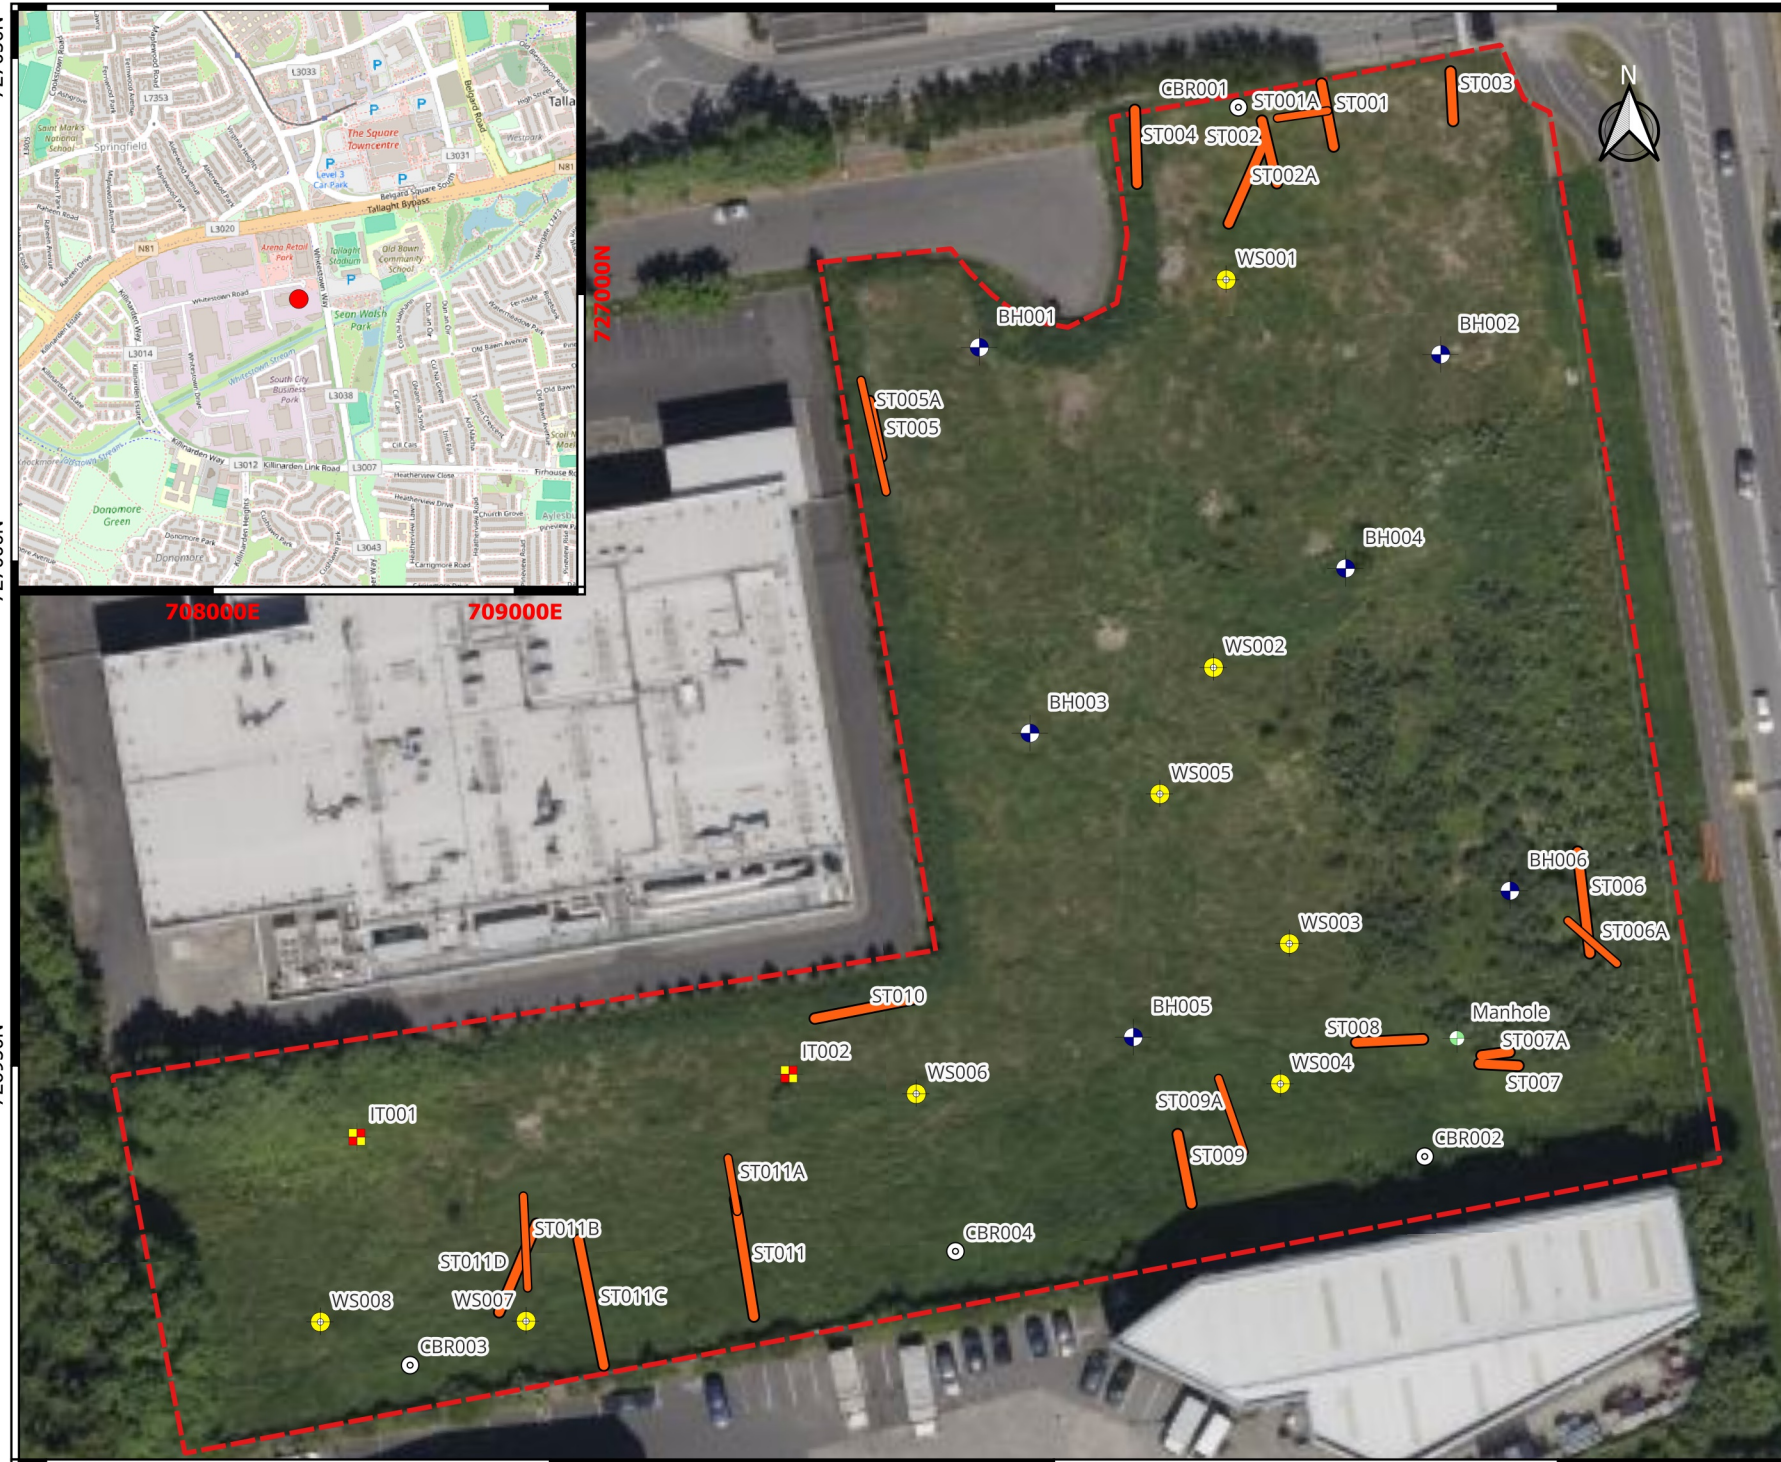
- Site Location
- Indicative Site Boundary
- Soakaway
- Slit Trench
- Window Sample
- Plate Bearing Test
- Cable Percussion Borehole
- Manhole

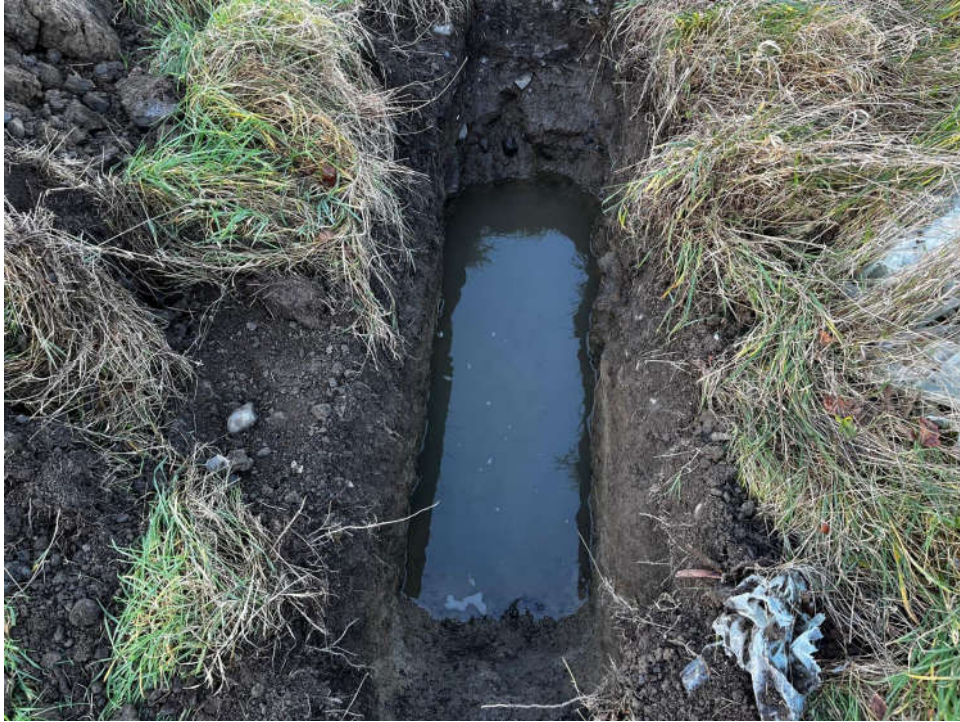
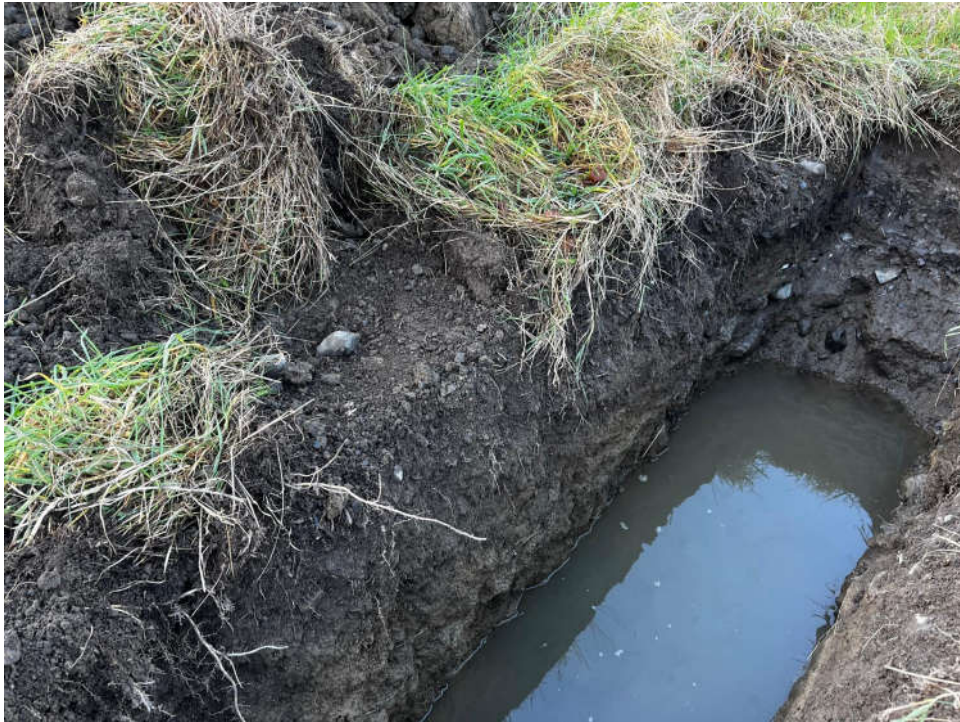
**IT001**

At the locations of IT001 and IT002 the water level dropped too slowly to allow calculation of 'f' the soil infiltration rate. These locations are therefore not recommended as suitable for soakaway design and construction.

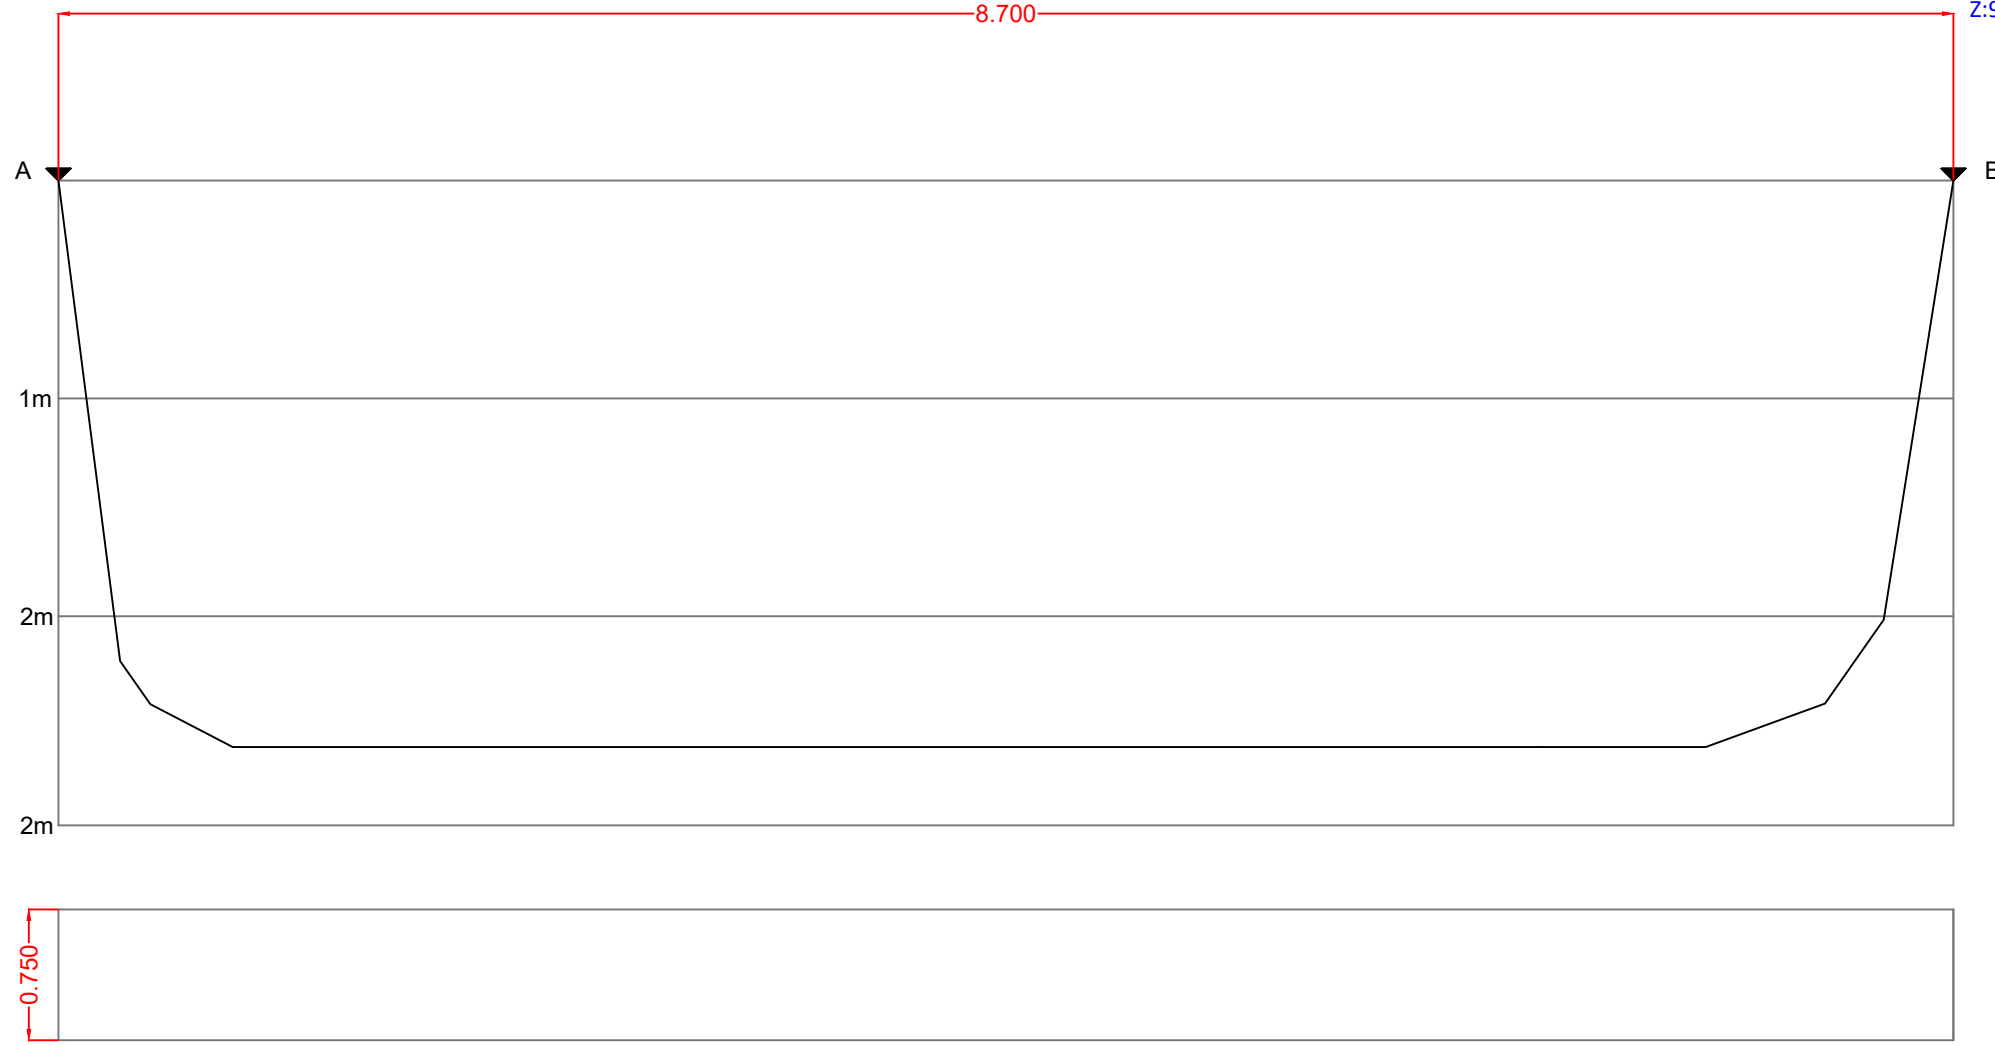
Service No	ø (m)	Colour - Material	Utility	Angle to trench	Coordinates		Level
					East	North	
S1	-	-	-	-	-	-	-

From (m)	To (m)	Description
0.00	0.20	TOPSOIL
0.20	2.60	MADE GROUND: Brown to light brown slightly sandy slightly gravelly Clay with fragments of red brick, plastic and metal.
